Performance of HUD-Affiliated Properties During the January 17, 1994 Northridge Earthquake

August 1994
Building and Fire Research Laboratory
National Institute of Standards and Technology
Gaithersburg, MD 20899

Prepared for:
U.S. Department of
Housing and Urban
Development

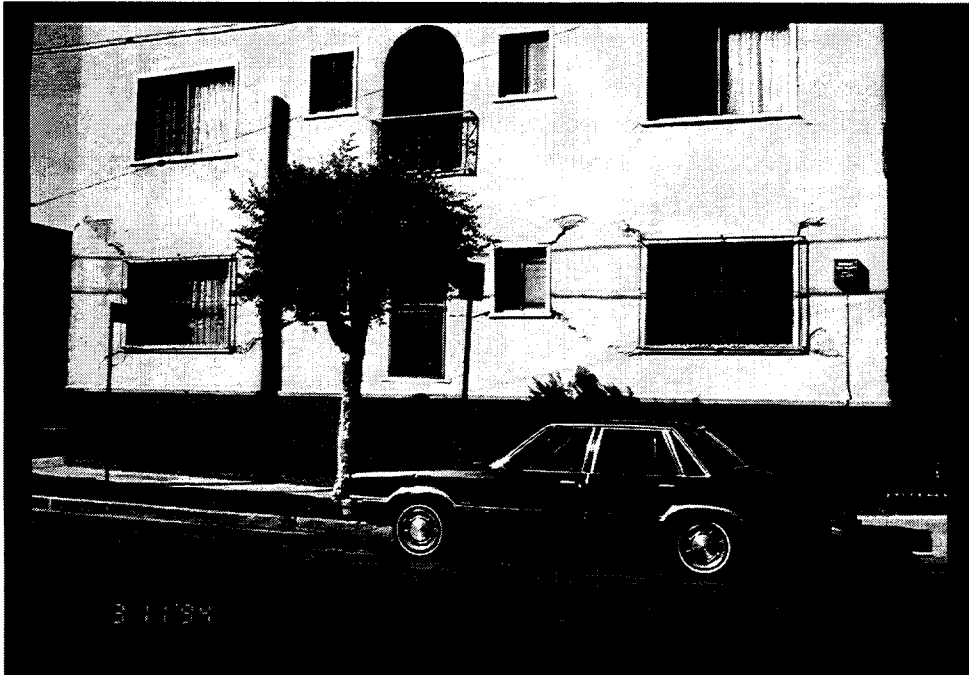
Figure 1 Residential construction is characterized by multiple door and window openings. The corners of these rectilinear openings create stress concentrations, making these locations particularly vulnerable to cracking.

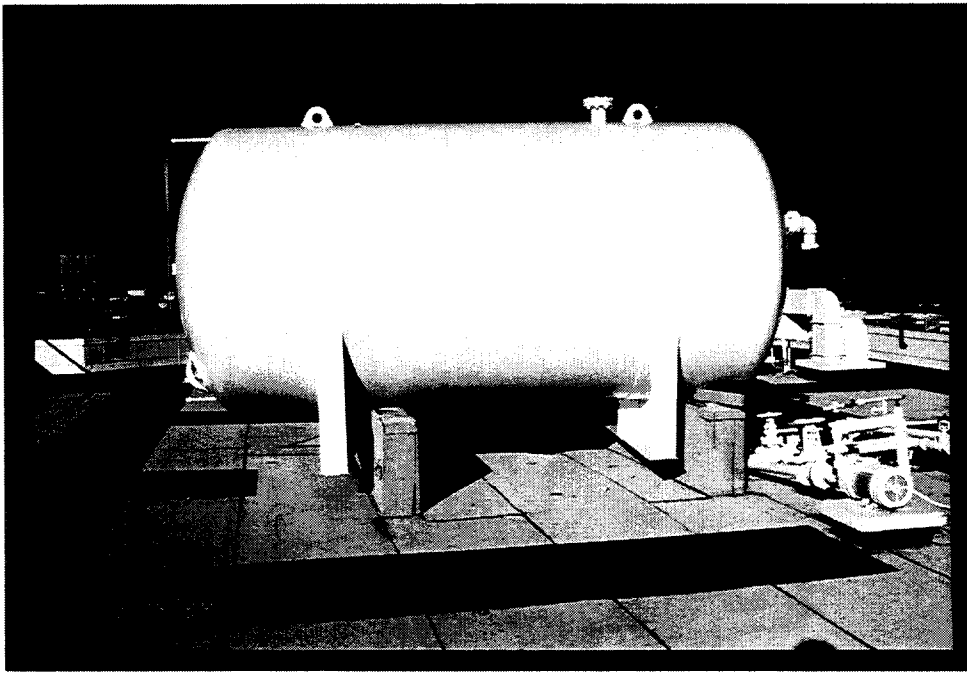
Figure 3 Movement of equipment, such as this 130,000 liter rooftop water tank at Fickett Towers, caused collateral damage in some cases. When this tank dropped from its supports, rupturing a water pipe, water damage to the building interior resulted.

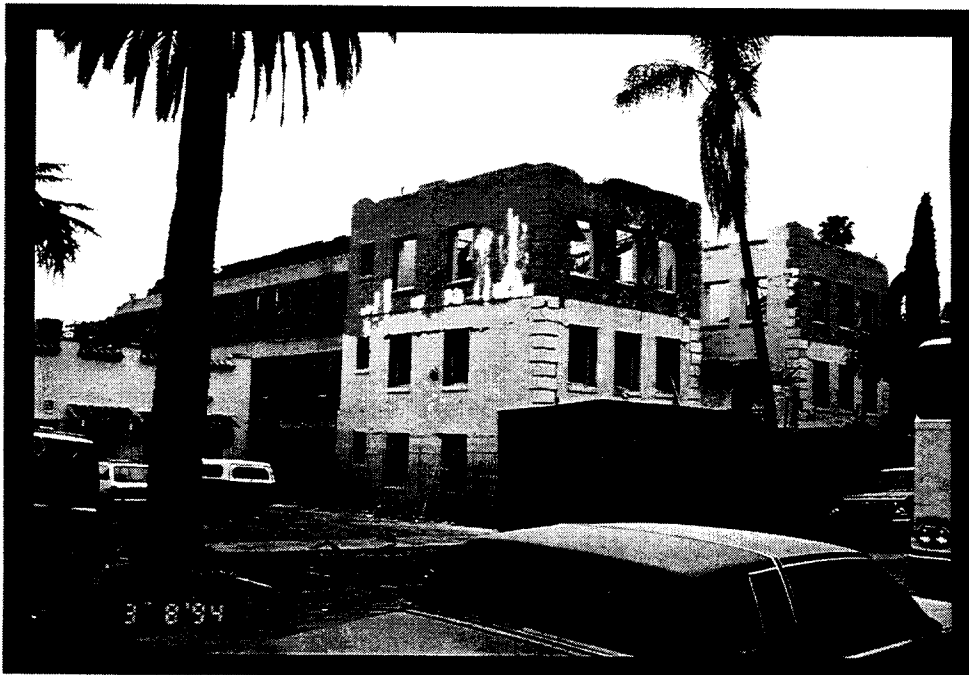
Figure 4 Vadehra IV, an unreinforced masonry building, was condemned because of extensive earthquake damage. When this photograph was taken, the top story had already been removed by the demolition team.

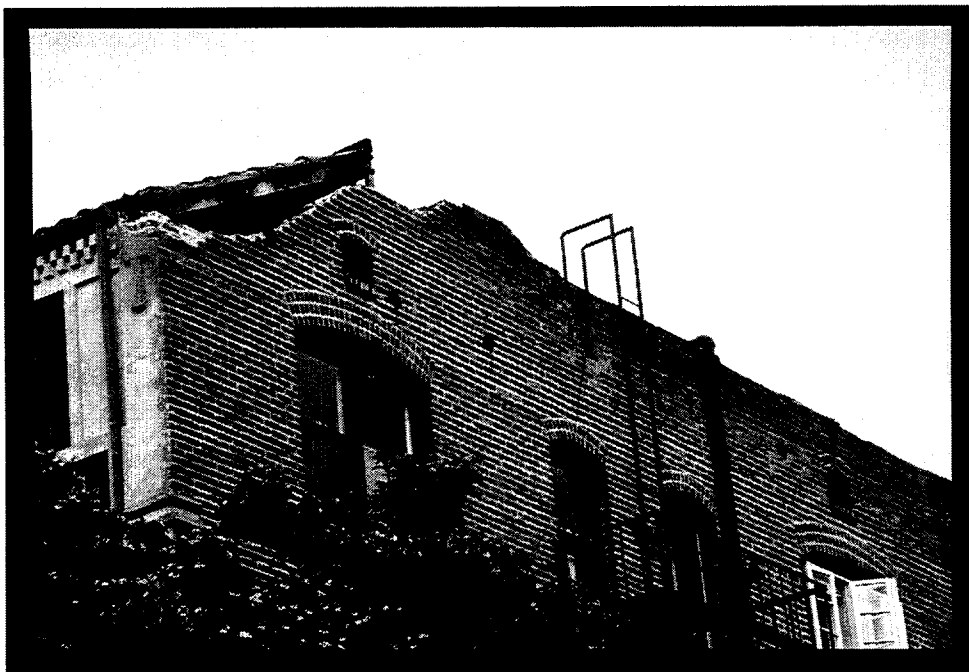
Figure 5 Loss of portions of the parapet and wall at Uptown Manor, an unreinforced masonry building, caused several living units to be declared unsafe by city inspectors.

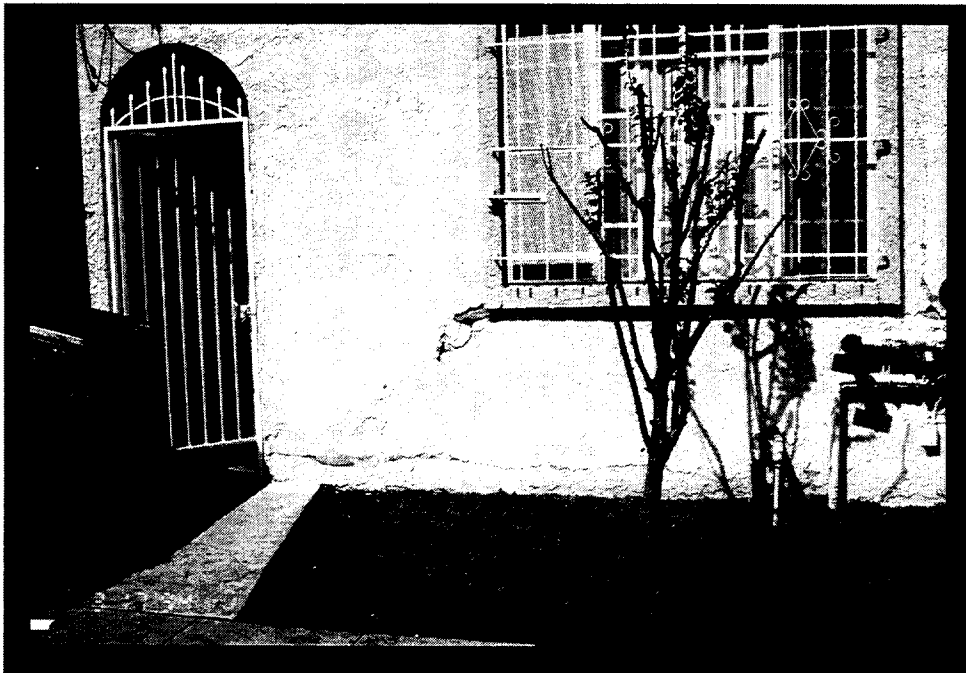
all 18 units pending more thorough evaluation (fig. 6). By far the largest number of unusable units in the survey occurred at Granada Gardens, a site of 51 wood frame buildings about 6.5 km from the epicenter. At this site, 120 of the 169 living units had to be evacuated due to structural damage.

Figure 6 *Sunset Apartments E, a three-story wood-frame apartment building, was declared by city inspectors to be potentially unsafe pending more detailed evaluation (yellow tagged). Note the horizontal crack in the stucco at the foundation line, the vertical crack to the right of the window, and the diagonal crack and buckled area of stucco at the lower corner of the window.*

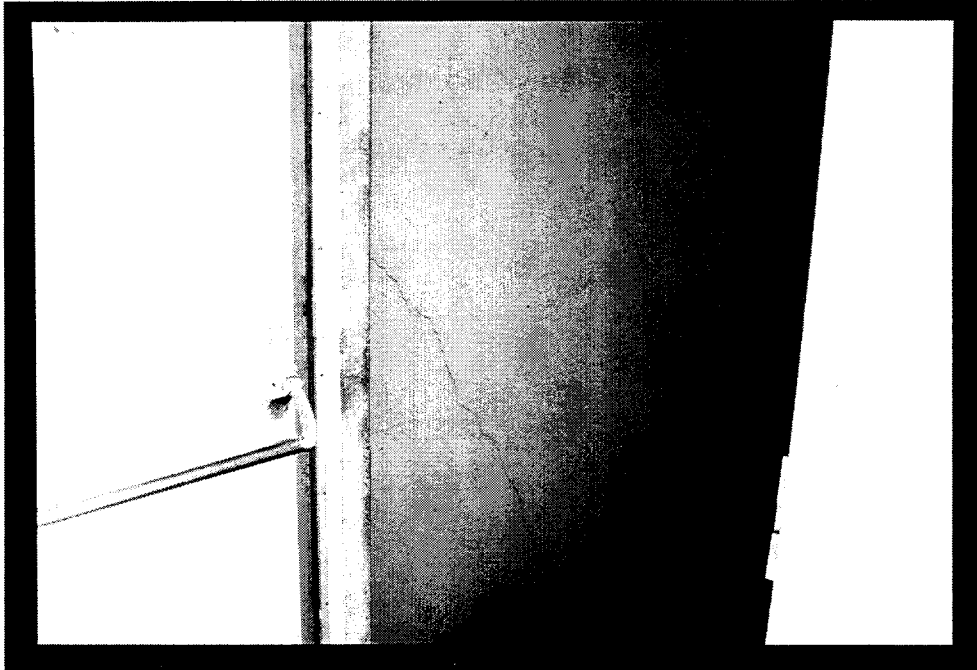
Figure 12 Structural damage in concrete buildings included diagonal cracks in shear walls, such as these in Beverly Towers.

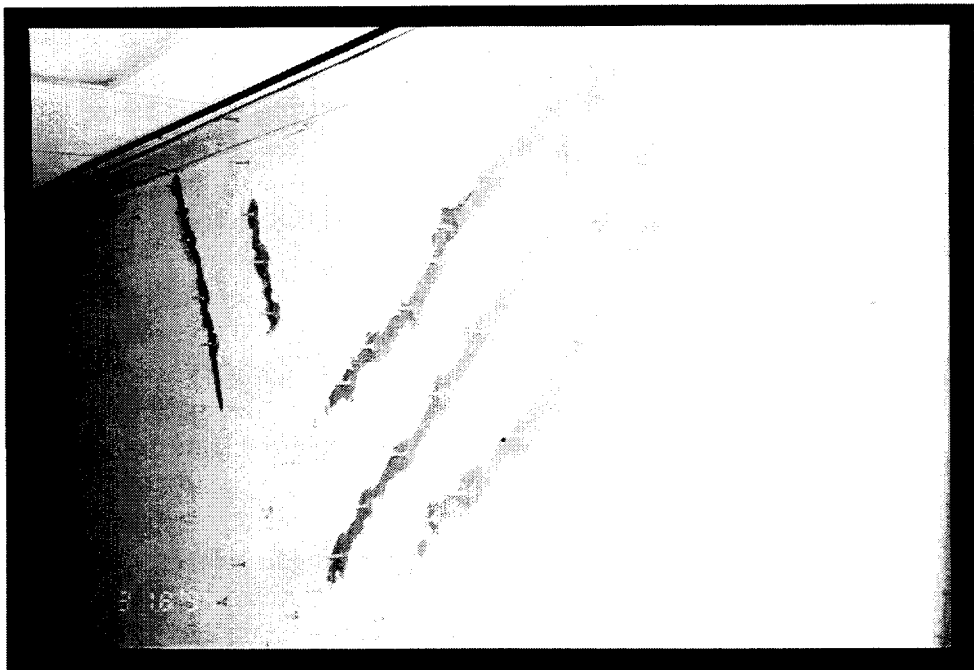
Figure 13 Some of the diagonal cracks in concrete shear walls were already under repair at the time of this study. At Santa Monica Christian apartments, cracks were being repaired using an epoxy injection technique.

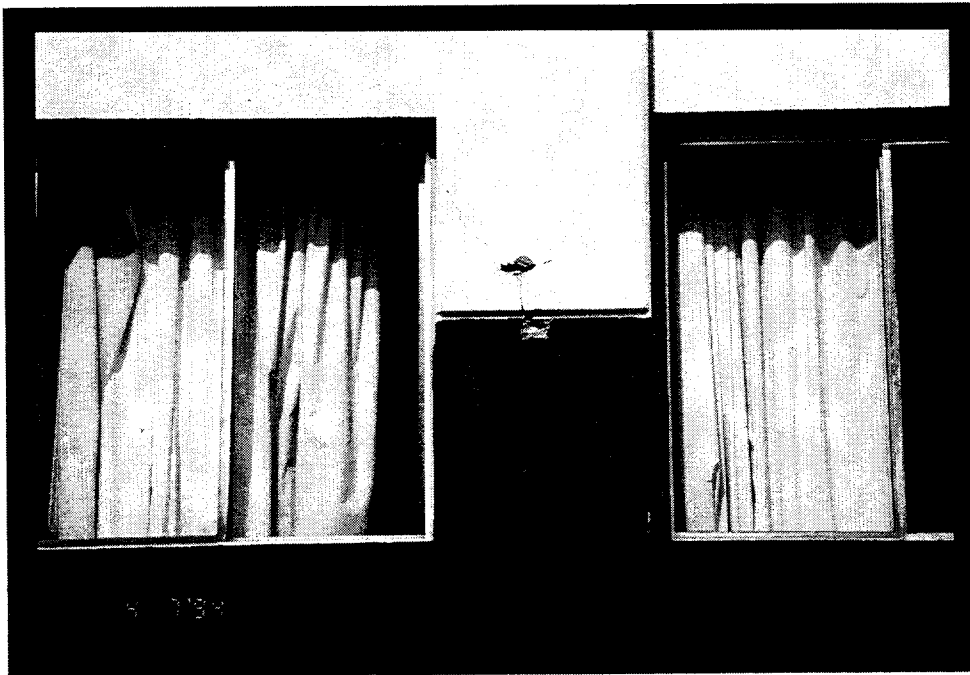
Figure 14 In concrete frame buildings, such as Westminster Towers, diagonal cracks in concrete columns were observed.

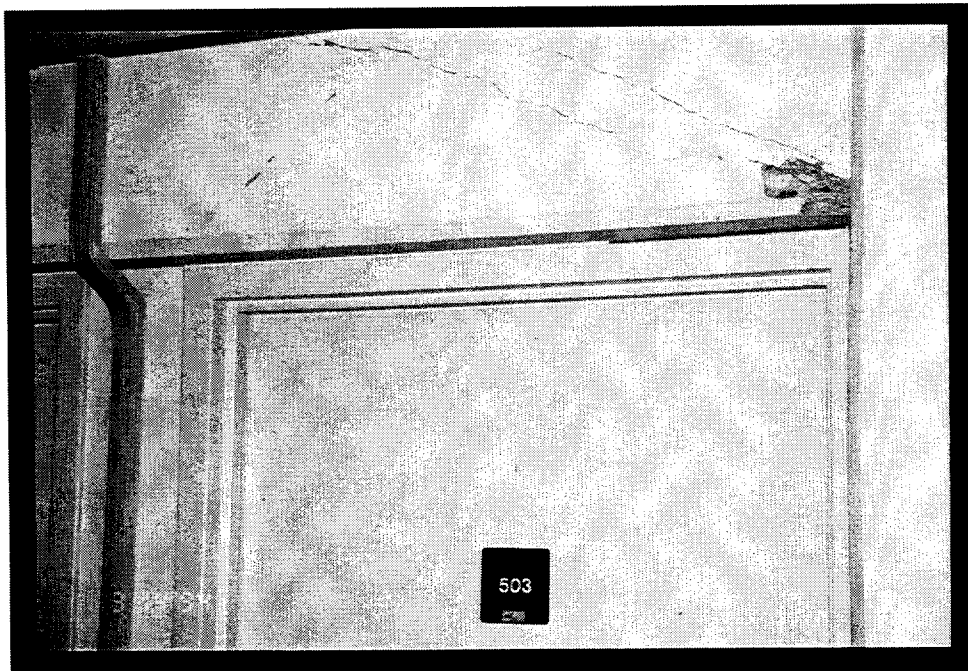
Figure 15 Diagonal cracks between openings in shear walls, such as these above a doorway at Fickett Tower, are examples of commonly observed earthquake damage in concrete shear wall buildings.

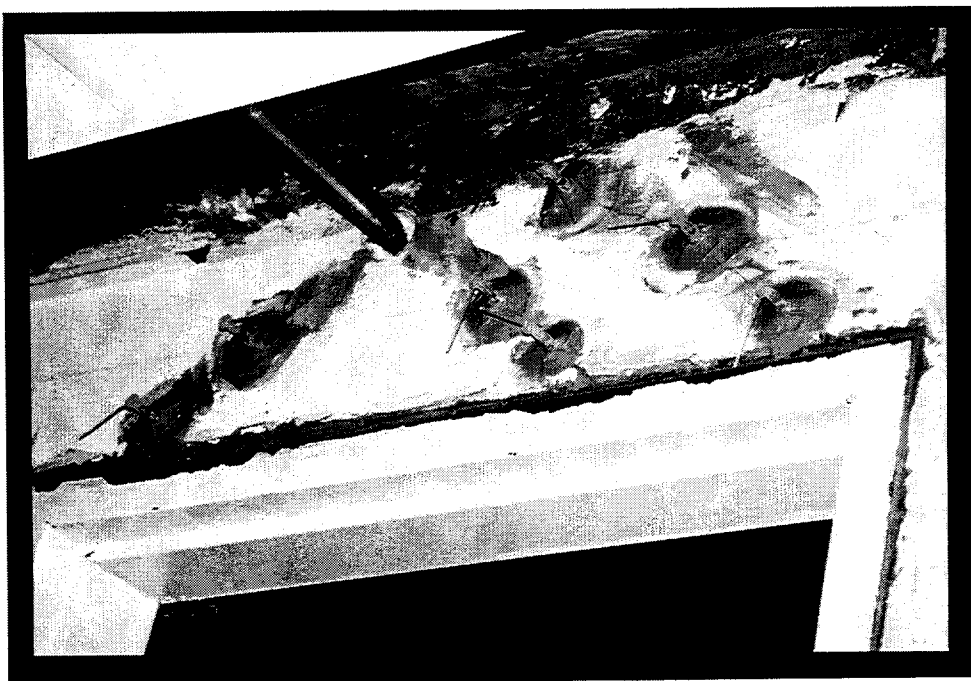
Figure 16 Diagonal cracks in the portions of the concrete shear wall above the doors at Santa Monica Christian apartments were being repaired using epoxy injection. This photograph shows the injection ports.

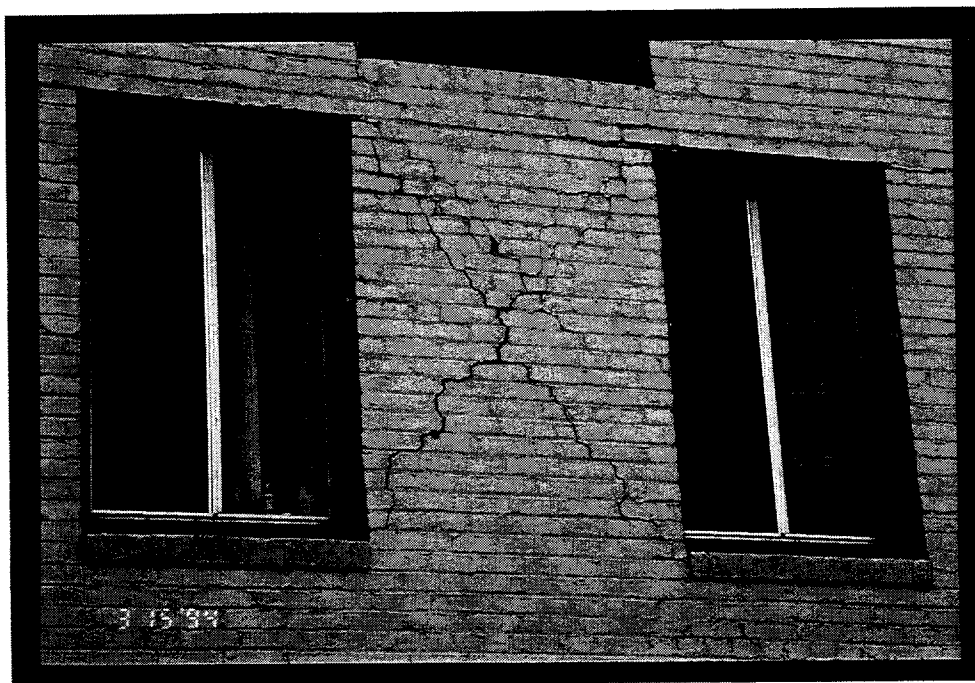
Figure 17 The masonry facade between windows at the Hollywood Knickerbocker, a 63-year old concrete frame building, displayed earthquake-induced X-cracking.

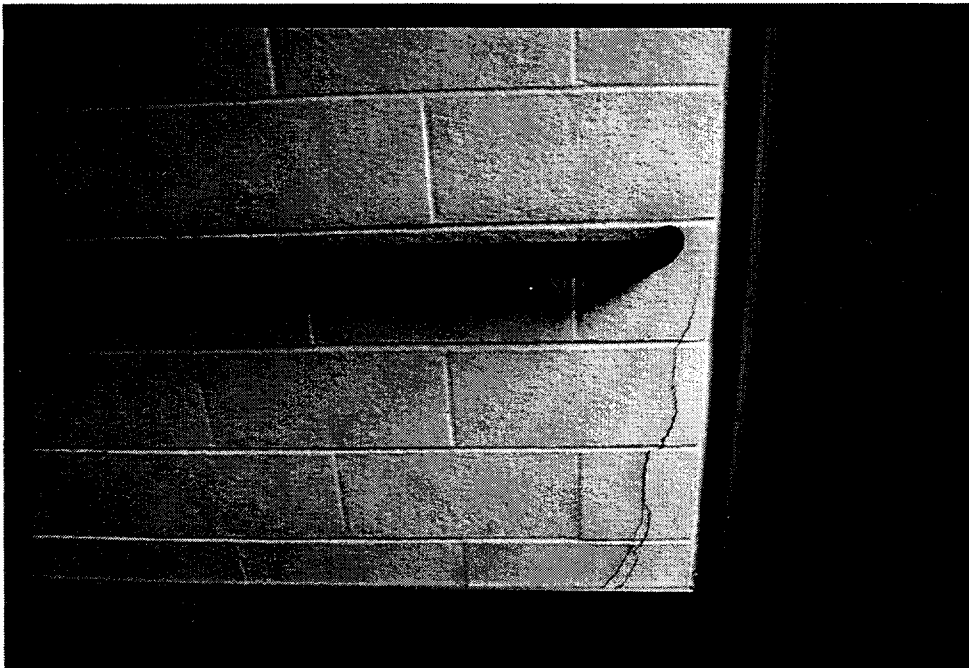
The other two sites had one building each. Casa La Merced is a 5-story building about 46 km from the epicenter which suffered only hairline cracks to interior nonstructural wall surfaces and no damage to structural or mechanical systems. Pledgerville Senior Citizens Villa is a 6-story building about 13 km from the epicenter that suffered vertical cracks in the walls near the base of the door openings (fig. 18).

Figure 18 At Pledgerville Senior Center, a 9-year old reinforced masonry building about 13 km from the epicenter, inclined vertical cracks were observed adjacent to door openings.

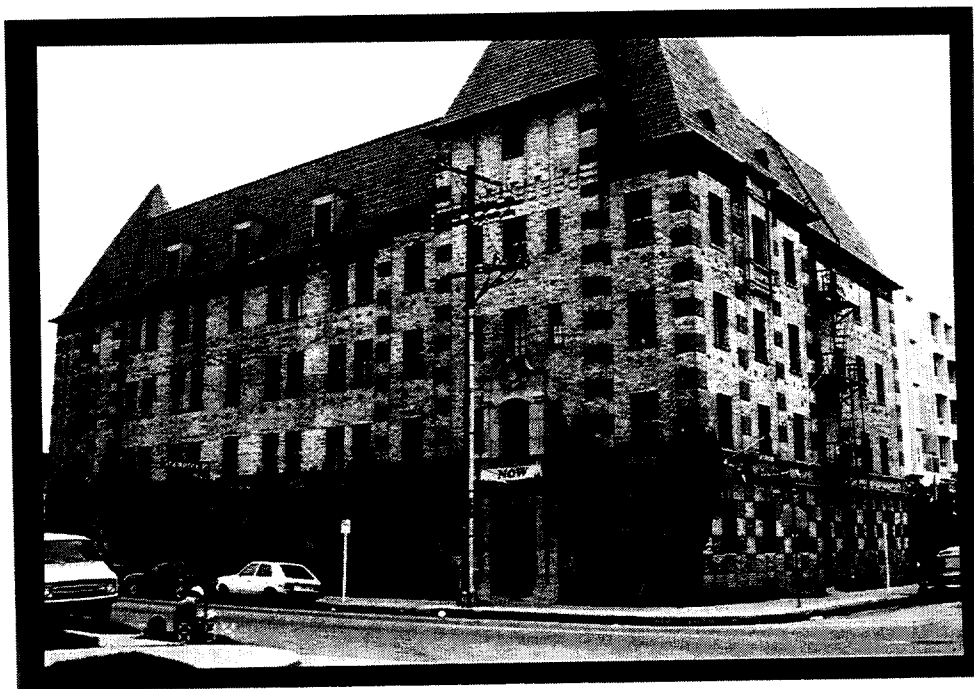
Figure 21 Villa Park Merridy, an unreinforced masonry building that had been rehabilitated prior to the Northridge earthquake, suffered no structural damage and only minor nonstructural damage.

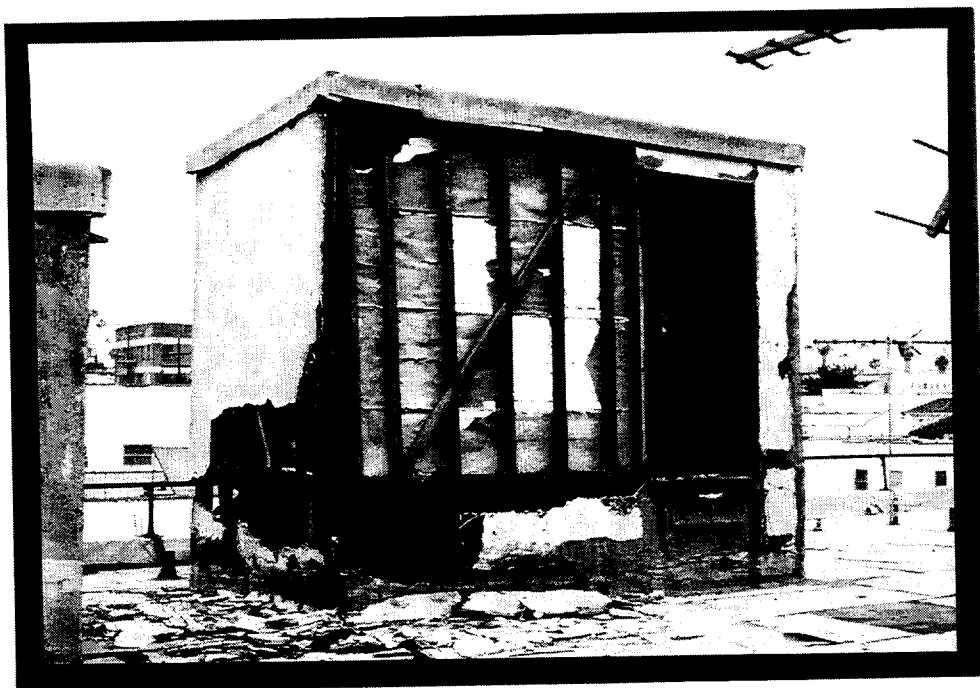
Figure 22 The wood-framed, stucco-clad elevator penthouse on the roof of the 3-story Vadehra IIIb building experienced extensive damage to the stucco, but the operation of the elevator was not affected.

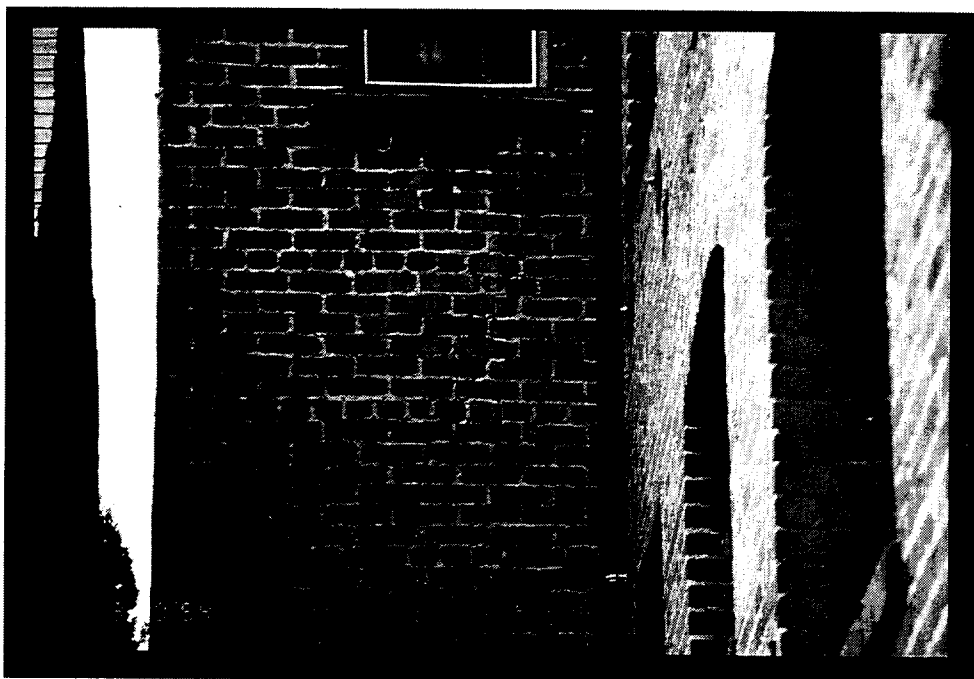
Figure 23 Vadehra IVb, a T-shaped unreinforced masonry building, suffered cracks in the short walls at the inside corner of the T that in some locations followed the line of the mortar and in other locations cracked brick units.

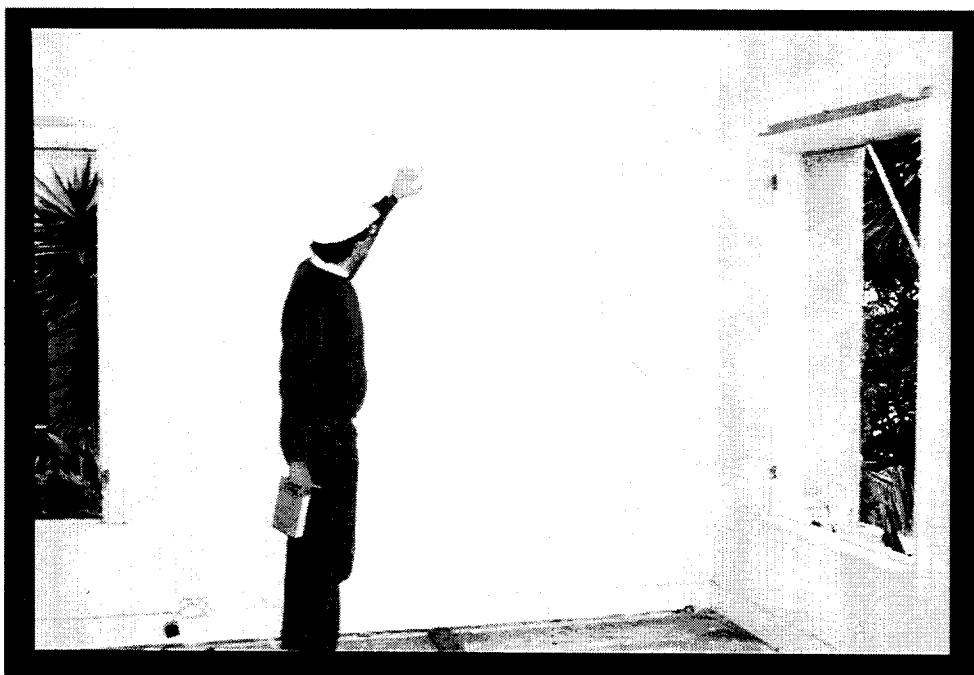
Figure 24 Damage observed in unreinforced masonry buildings included cracks in the interior plaster.

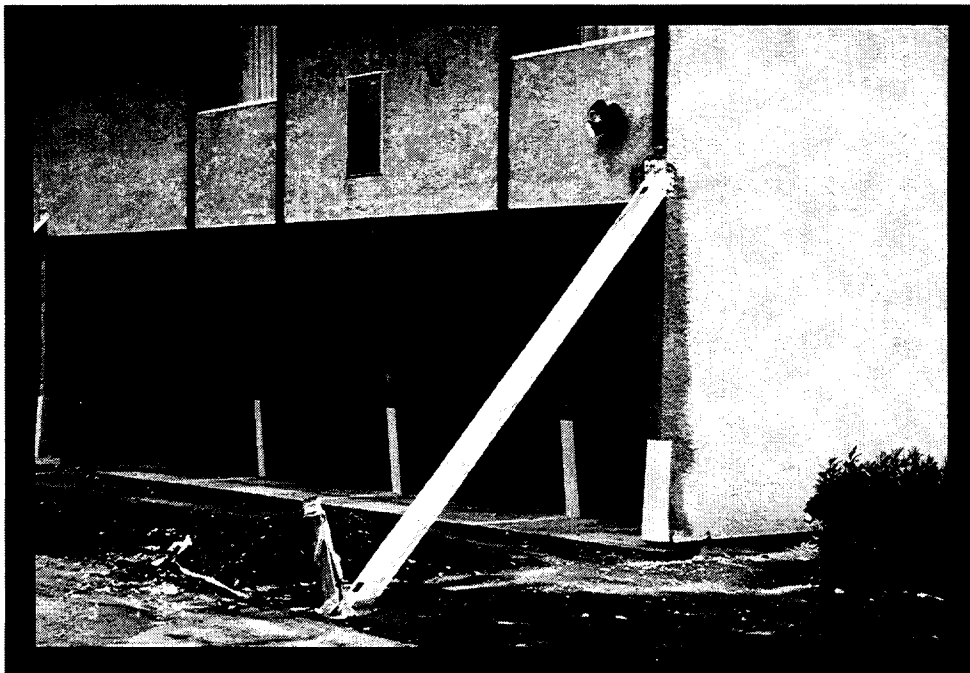
Figure 25 At Granada Gardens, many of the two-story wood frame buildings that had open first levels for parking experienced significant racking and permanent offsets.

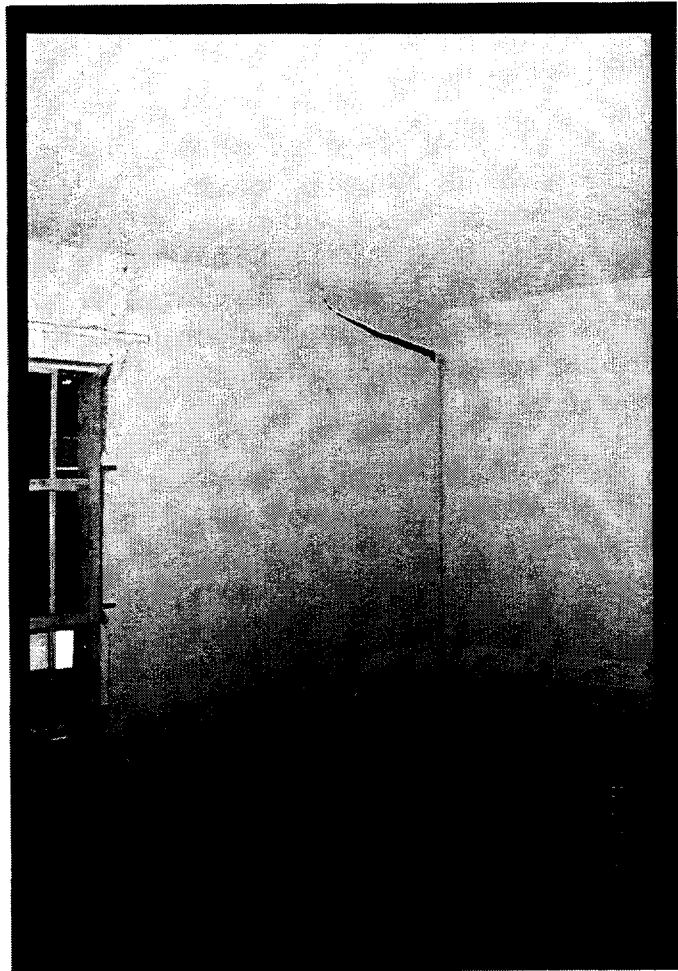
Figure 26 Interior damage at Granda Gardens included cracks in the gypsum wallboard.

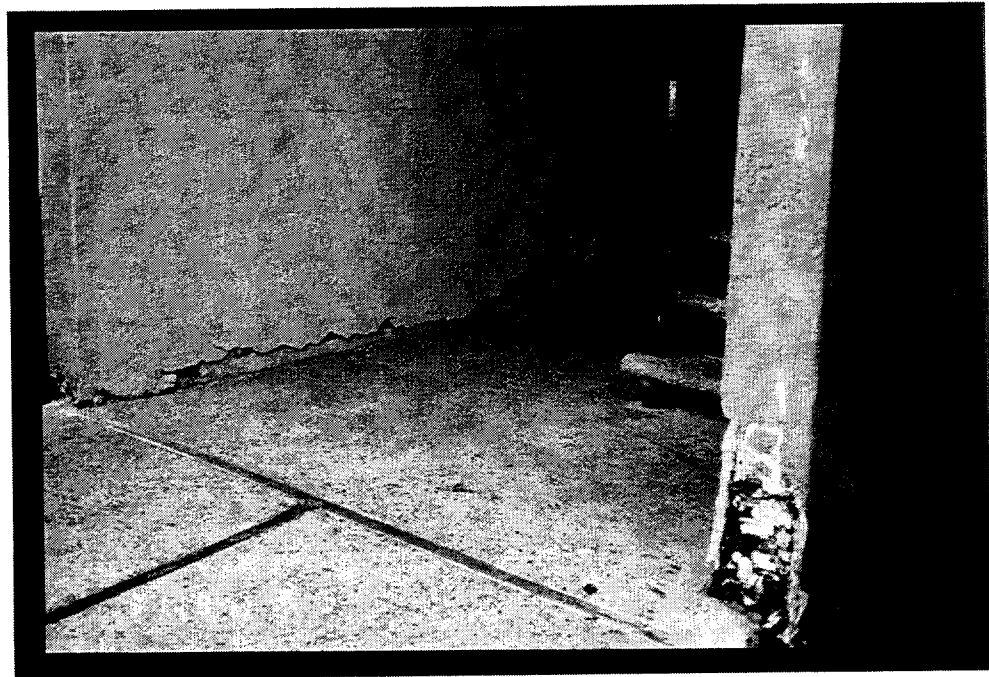
Figure 27 Horizontal cracks in exterior stucco occurred where the relatively flexible wood frame walls joined the more rigid concrete foundation walls.

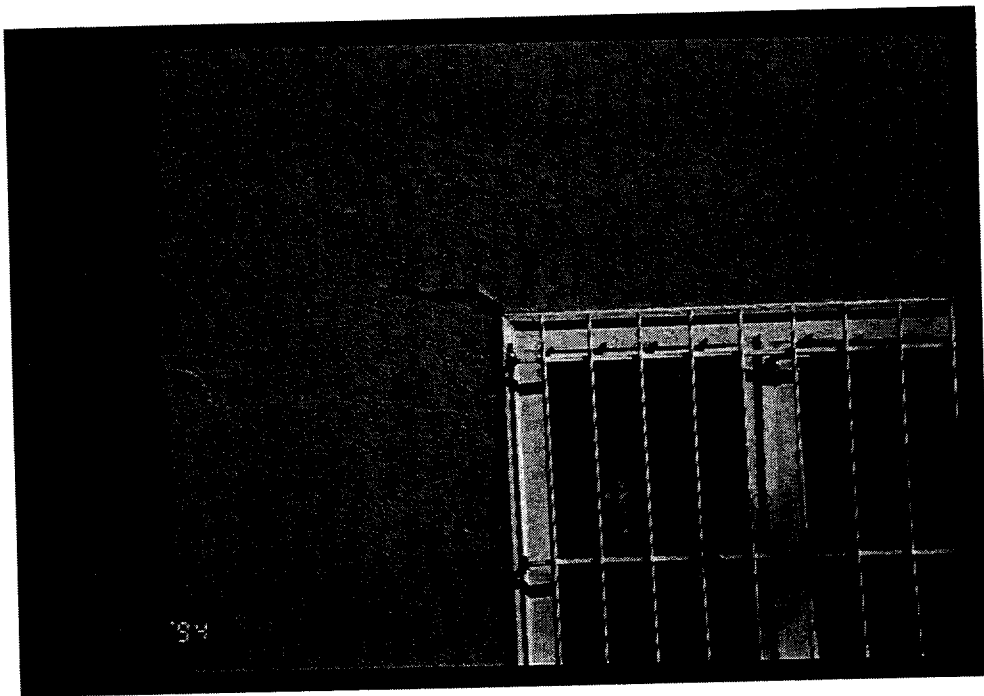
Figure 28 Diagonal cracks in exterior stucco at window openings in wood-framed buildings occurred in many locations, such as at this window at Miramar Manor.
